OPERATION PLUMBBOB

NEVADA TEST SITE
MAY-OCTOBER 1957

Project 30.7

TEST OF GERMAN UNDERGROUND
PERSONNEL SHELTERS

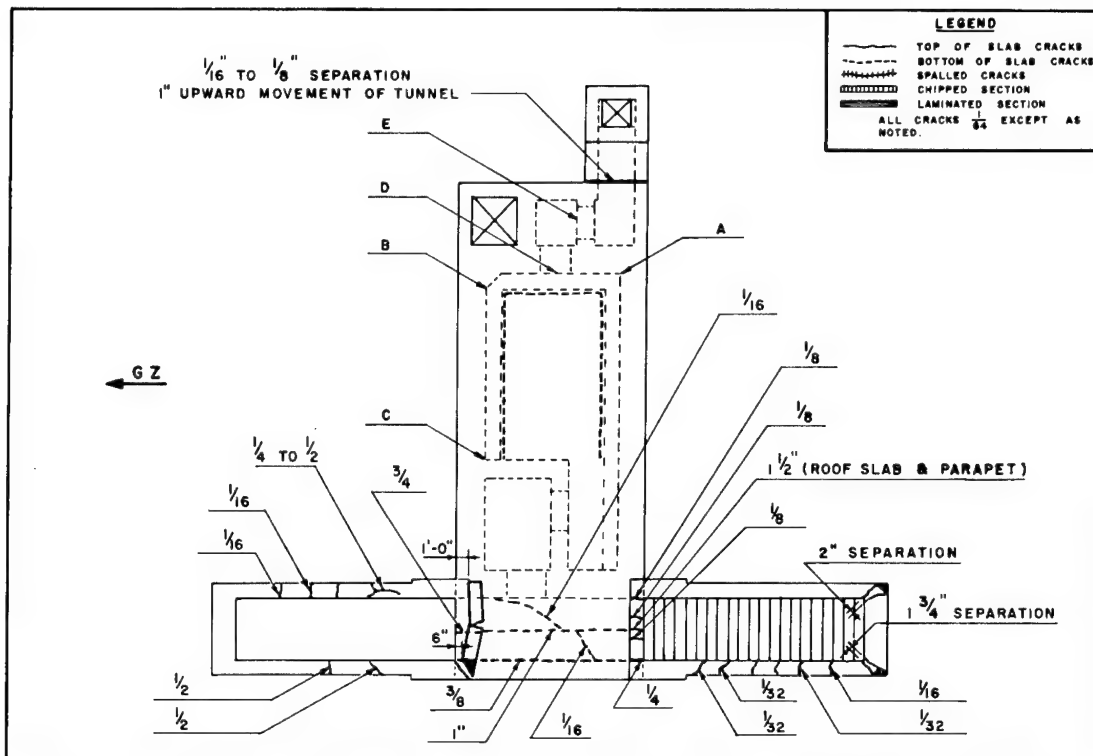
(c) *Main Chamber.* Hairline cracks were formed at the intersection of the roof slab and the haunches along the rear and side walls of the main chamber. The intersection of the walls located at points A, B, and C of Fig. 3.1 had continuous hairline cracks the full height of the walls. Diagonal hairline cracks were formed at the four corners of the door opening located at point D. Numerous transverse and longitudinal hairline cracks were produced on the floor slab of the main chamber. No cracks were present in the floor slab of the main chamber adjacent to the main seal door.

The crack patterns for structure RAa are shown in Figs. 3.1 to 3.3. Appendix C contains the postshot dynamic analysis of the roof slab of shelter RAa. The analysis indicates that only minor cracking was expected under the applied blast load.

(d) *Exit Chamber.* As in the main chamber, diagonal cracks were formed at the four corners of the door opening located at point E, Fig. 3.1. No structural damage was evident in the roof and floor slabs.

Fig. 3.1—Roof-slab crack pattern (structure RAa).

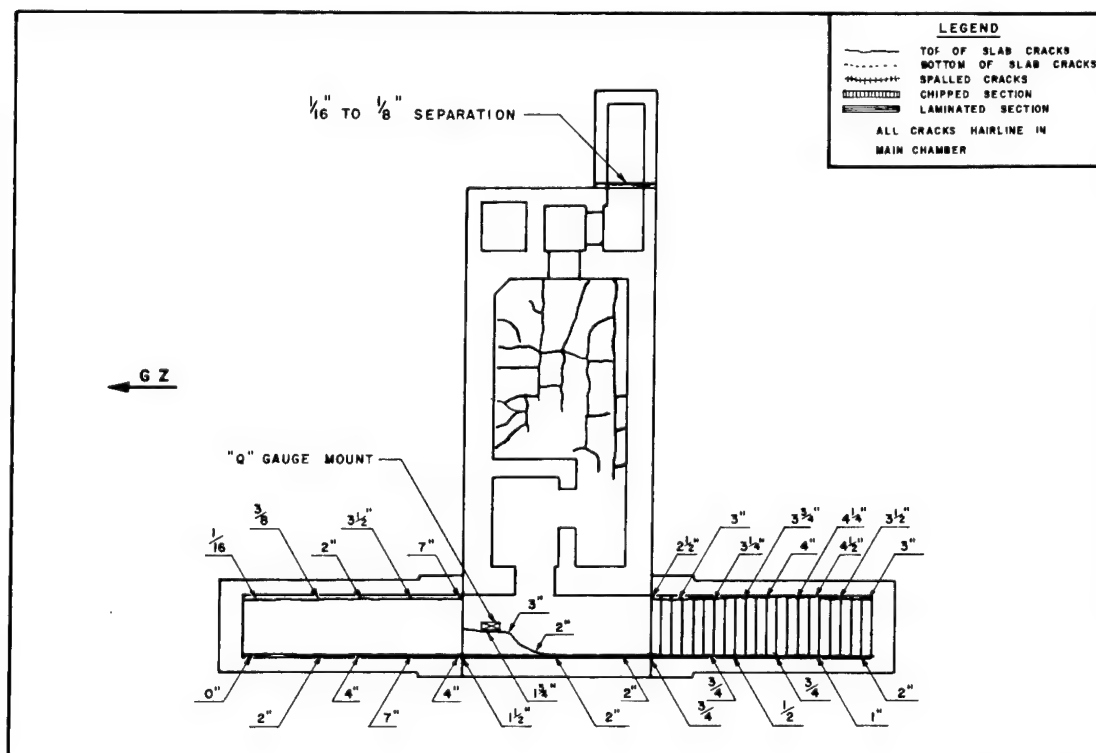
Fig. 3.2—Floor-slab crack pattern (structure RAa).

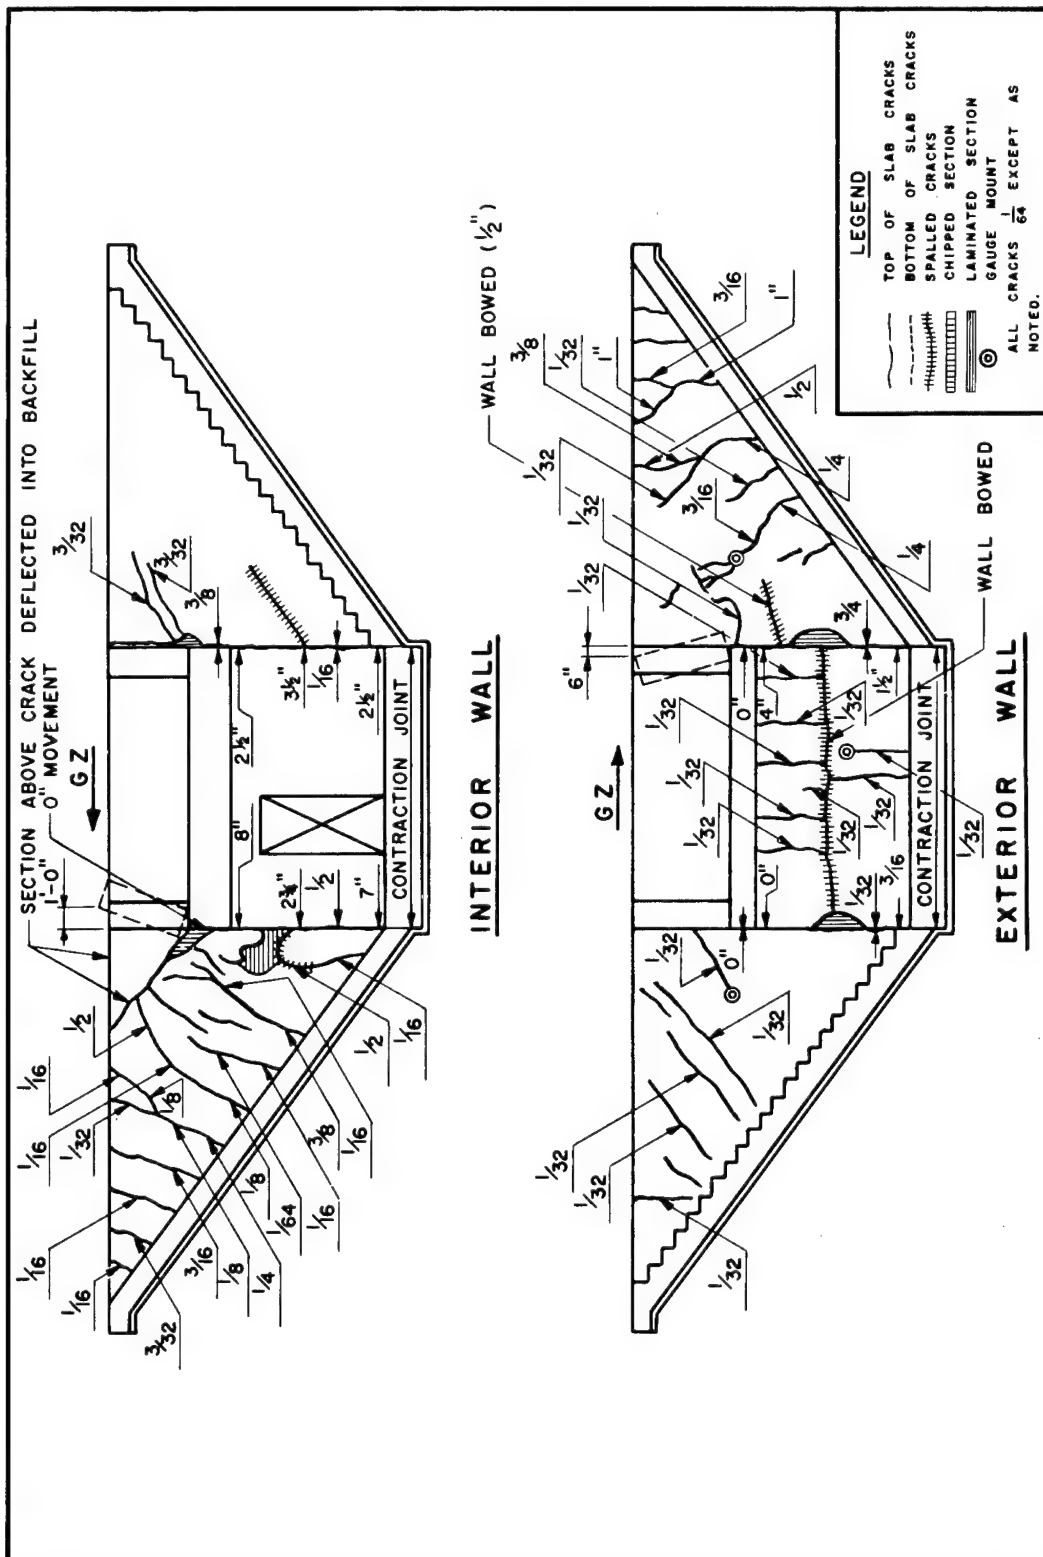
(a) *Entranceways.* In the ramp entrance facing GZ separations formed at the intersections of the interior and exterior walls with the ramp slab. The interior wall was pulled away from the slab 7 in. at the bottom and $\frac{1}{16}$ in. at the top of the ramp. The intersection of the ramp and exterior wall was similar to that at the interior wall; that is, the crack varied from 4 to 7 in. near the bottom to zero inches at the top of the ramp. Bowing of the interior wall into the backfill was produced at the quarter-height along the contraction joint. A $\frac{1}{16}$ - to $\frac{1}{2}$ -in. vertical crack was formed near the bottom of the ramp. This crack terminated at a laminated area located at the mid-height of the wall. There was spalling on both sides at the upper section of the crack. Cracks varying from $\frac{1}{16}$ to $\frac{3}{8}$ in. in width, perpendicular to the plane of the ramp, were located approximately 2 ft on center along the length of the wall. The majority of these cracks ran the full height of the wall. A crack starting at a chipped-out section located at the intersection of the end of the roof slab and the interior wall ran diagonally toward the top of the wall. The section of the wall above this crack was deflected back into the fill. The exterior wall damage was similar to that described for the interior wall. A chipped section of the exterior ramp wall was located approximately 4 ft above the landing at the contraction joint. A horizontal crack, with spalling on both sides, above this section produced a $\frac{1}{2}$ -in. bow in this wall. There were numerous diagonal cracks perpendicular to the plane of the ramp located approximately 2 to 3 ft on center in the upper two-thirds of wall. These cracks varied in size from $\frac{1}{32}$ to 1 in. in width. The top of the parapet located above the landing roof slab that faces GZ was deflected into the backfill 6 in. at the intersection of the exterior wall and 1 ft at the interior wall. The corners of the parapet and side walls were chipped, and the reinforcement was exposed.

A 3-in. crack in the landing floor slab ran from the contraction joint at the bottom of the ramp along the center line of the slab to the Q-gauge mount. There it became a 2-in. crack, running diagonally to the exterior wall. A $\frac{1}{2}$ - to 2-in. crack was located along the intersection of the floor slab and the exterior wall. The crack was continuous the full length of the landing. The roof slab had a continuous longitudinal 1-in. crack along its center line. Two diagonal cracks $\frac{1}{16}$ in. in width branched off the main crack, one terminating at the interior wall and the other at the exterior wall. A $\frac{3}{8}$ -in. crack was produced along the intersection of the roof slab and the exterior wall. The exterior wall was badly damaged, having a longitudinal crack located at the mid-height of the wall. Spalling of 2 to 3 in. on each side was observed along its entire length.

Fig. 3.3—Entrance crack pattern (structure RAa).

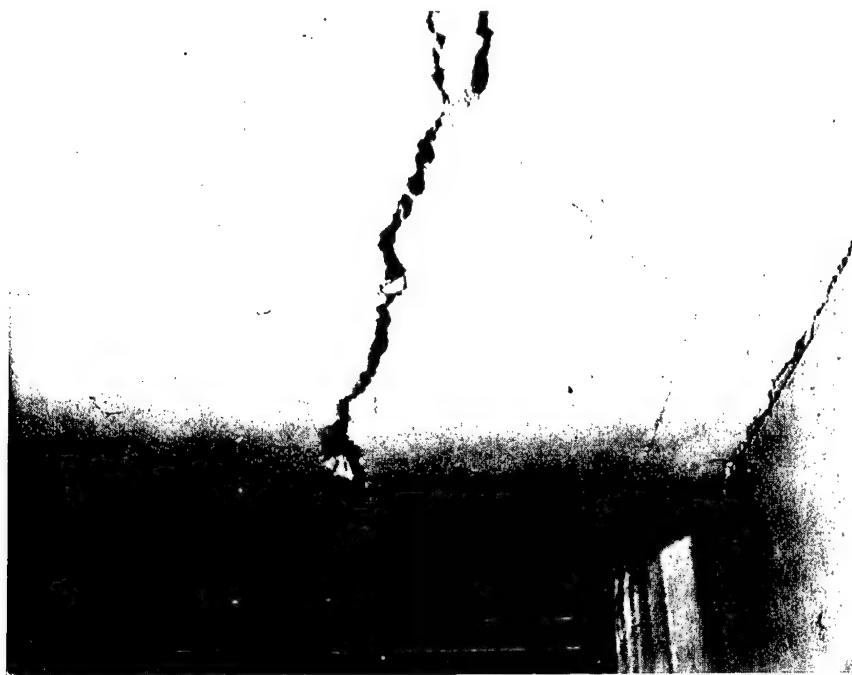
Fig. 3.9—Cracks along center of landing roof slab and at intersection with exterior wall (structure RAa).

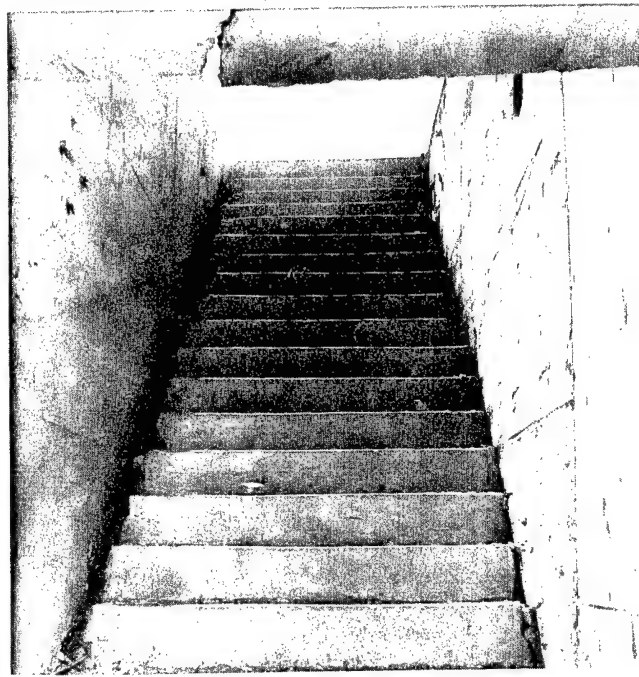
stairs. The exterior wall had several $\frac{1}{32}$ -in. cracks perpendicular to the plane of the stairs located in the upper section of the entrance. The interior wall had a spalled crack located at its quarter point which started at the contraction joint, ran parallel to the stairs, and ended above the sixth riser from the bottom. At the intersection of the top end of the roof slab and the interior wall was a chipped-out section of the wall. This section had two $\frac{3}{32}$ -in. cracks leading out from it and running parallel to the stairs.

Fig. 3.10—Looking up stairs away from GZ (structure RAa).

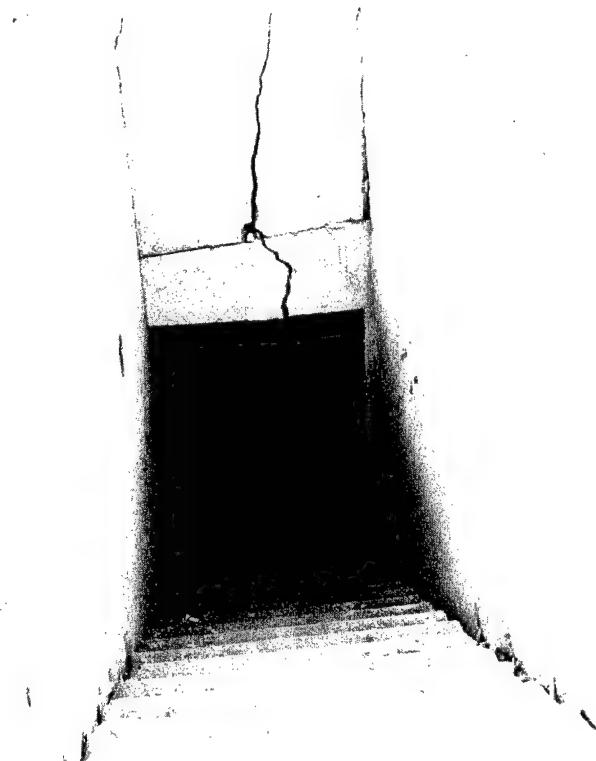
Fig. 3.11—Cracks in parapet wall and end of landing roof slab at entrance facing away from GZ (structure RAa).

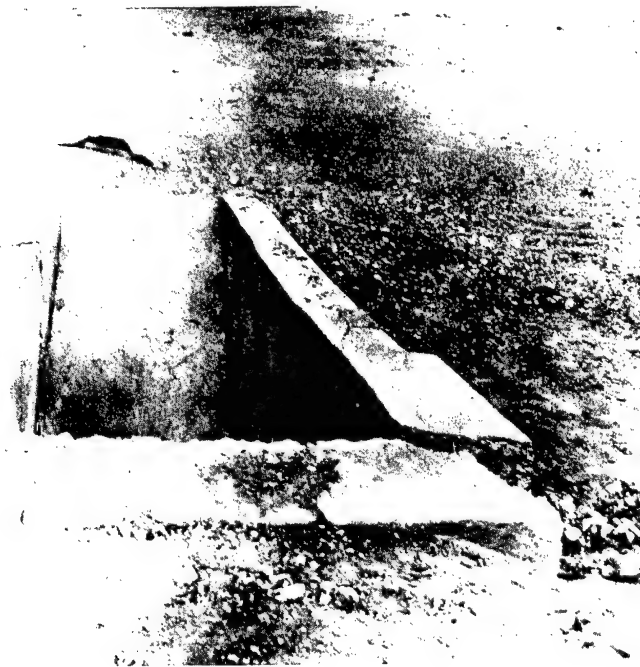
Fig. 3.13—Blast damage to ramp walls of entrance facing GZ (structure RAa).

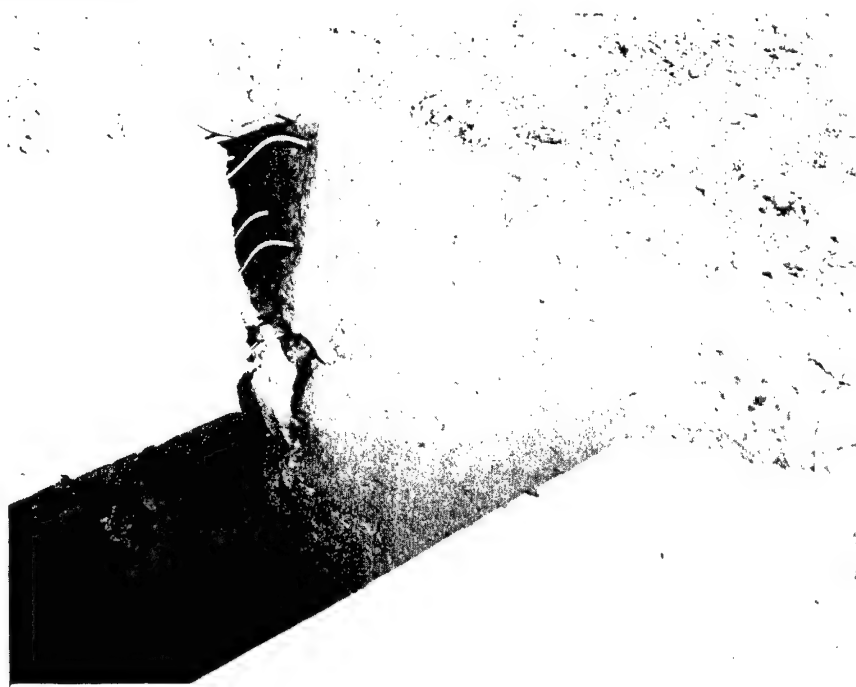
Fig. 3.15—Blast damage at intersection of interior wall and parapet wall facing toward GZ. (structure RAa).

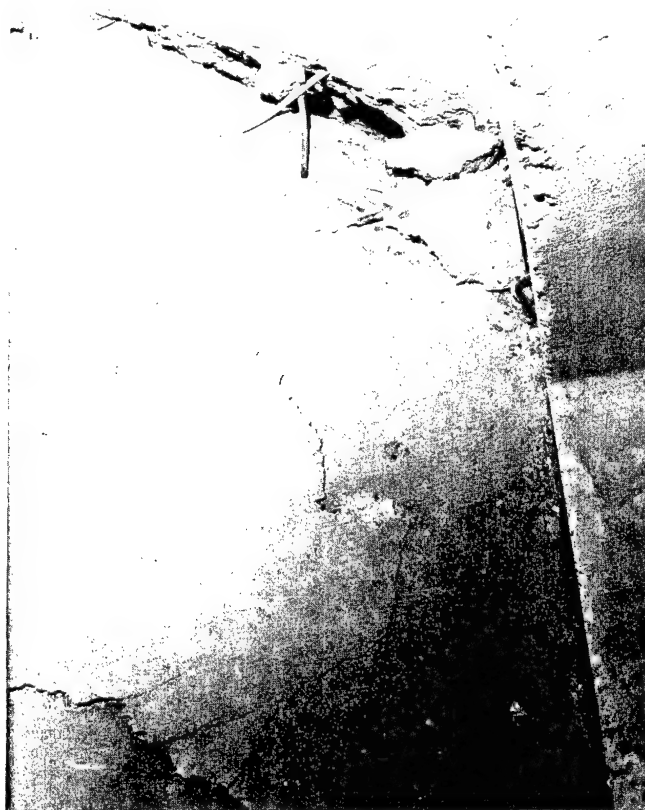
Fig. 3.16—Detail of cracks and spalled and laminated area in interior wall at contraction joint at entrance facing toward GZ (structure RAa).

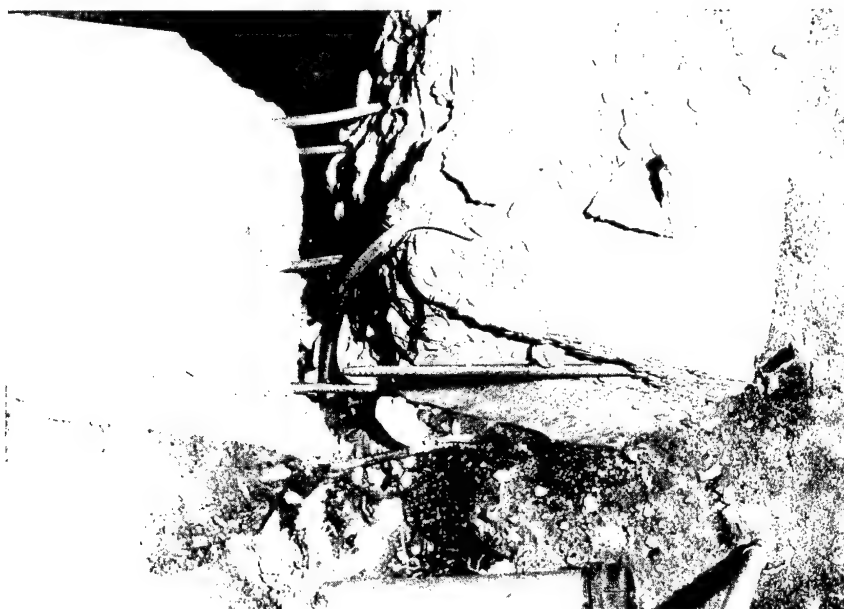
Fig. 3.17—Detail of crack at intersection of exterior wall and parapet wall facing toward GZ (structure RAa).

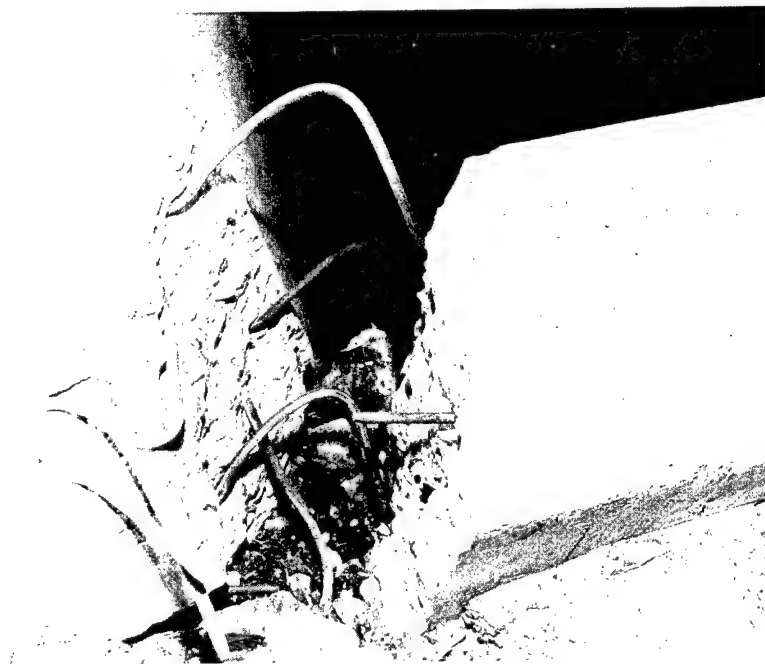
Fig. 3.19—Detail of crack at intersection of interior wall and parapet wall facing toward GZ (structure RAa).

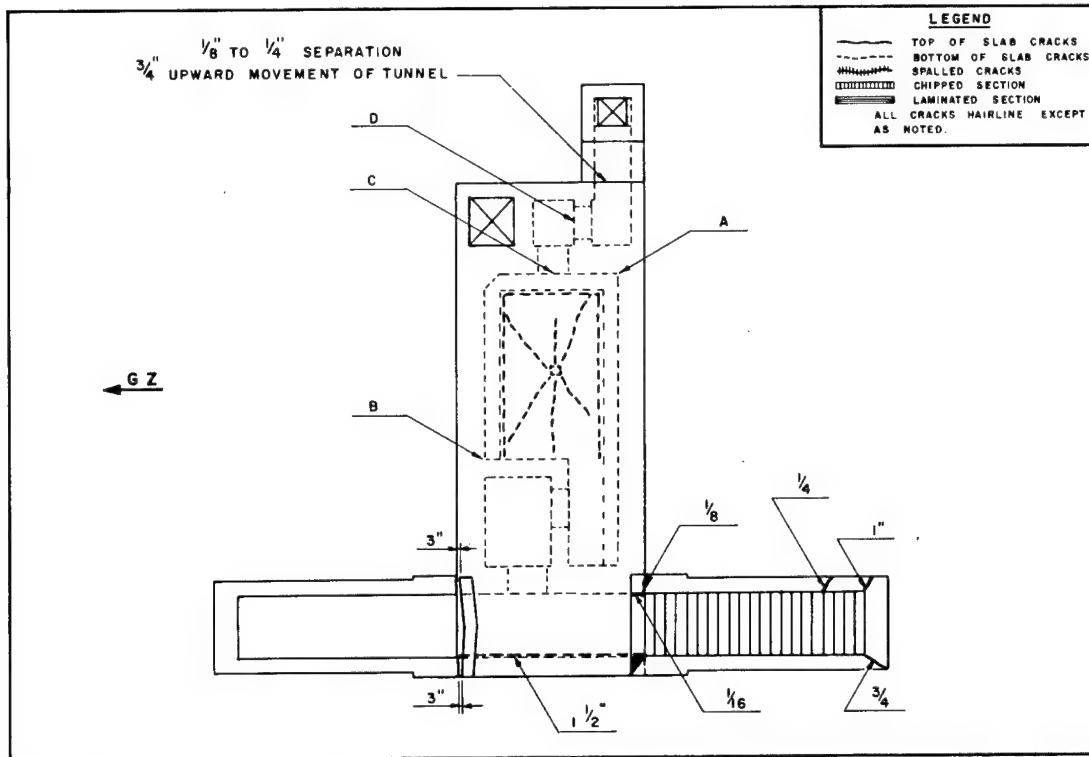
Fig. 3.25—Roof-slab crack pattern (structure RAb).

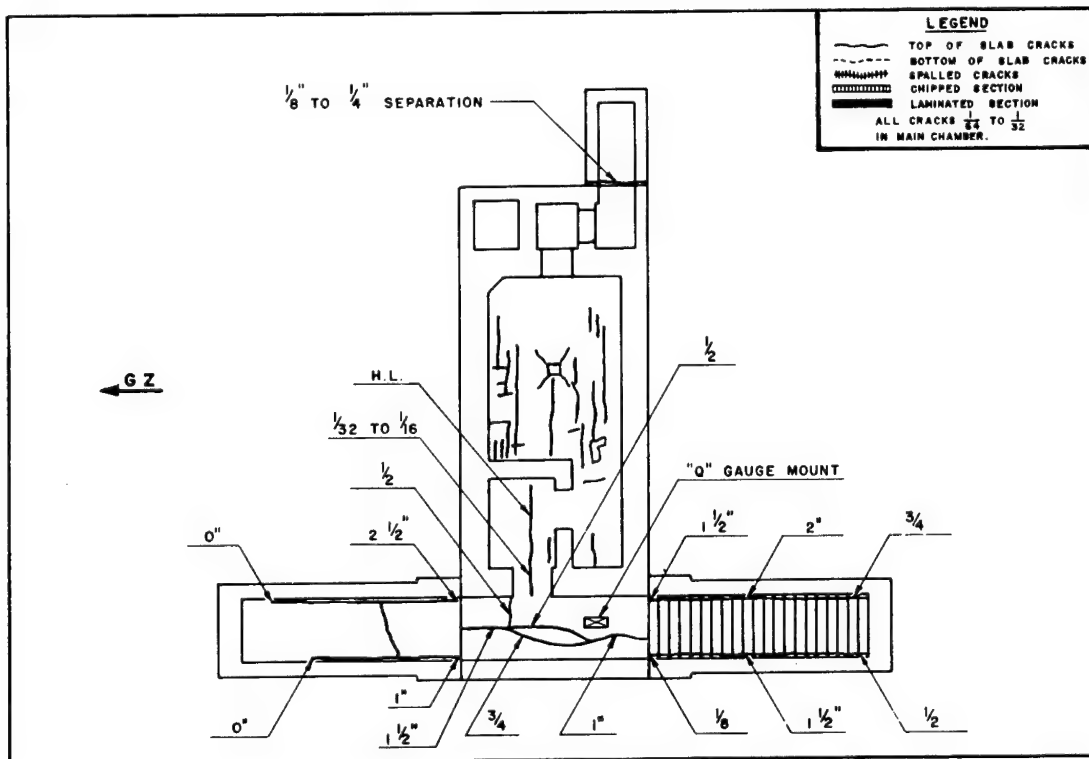
Fig. 3.26—Floor-slab crack pattern (structure RAb).

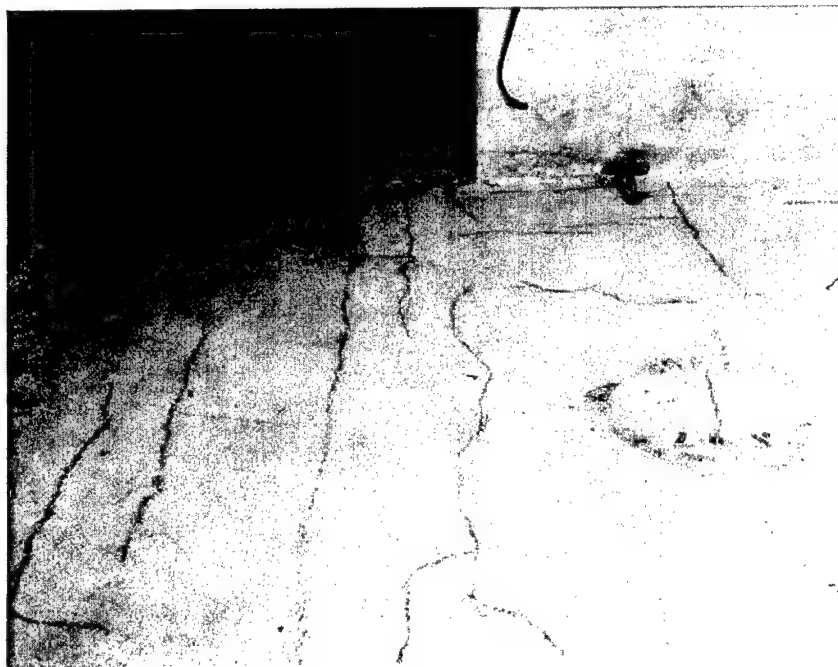
Fig. 3.28—Cracks in floor slab of main chamber, looking toward main entrance (structure RAb).

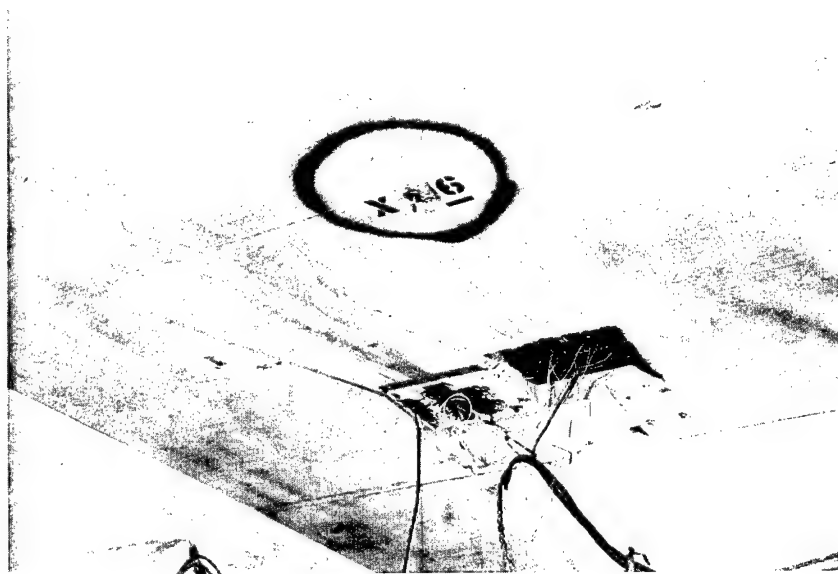
Fig. 3.29—Cracks, strain-gauge recess, and survey point in roof slab of main chamber (structure RAb).

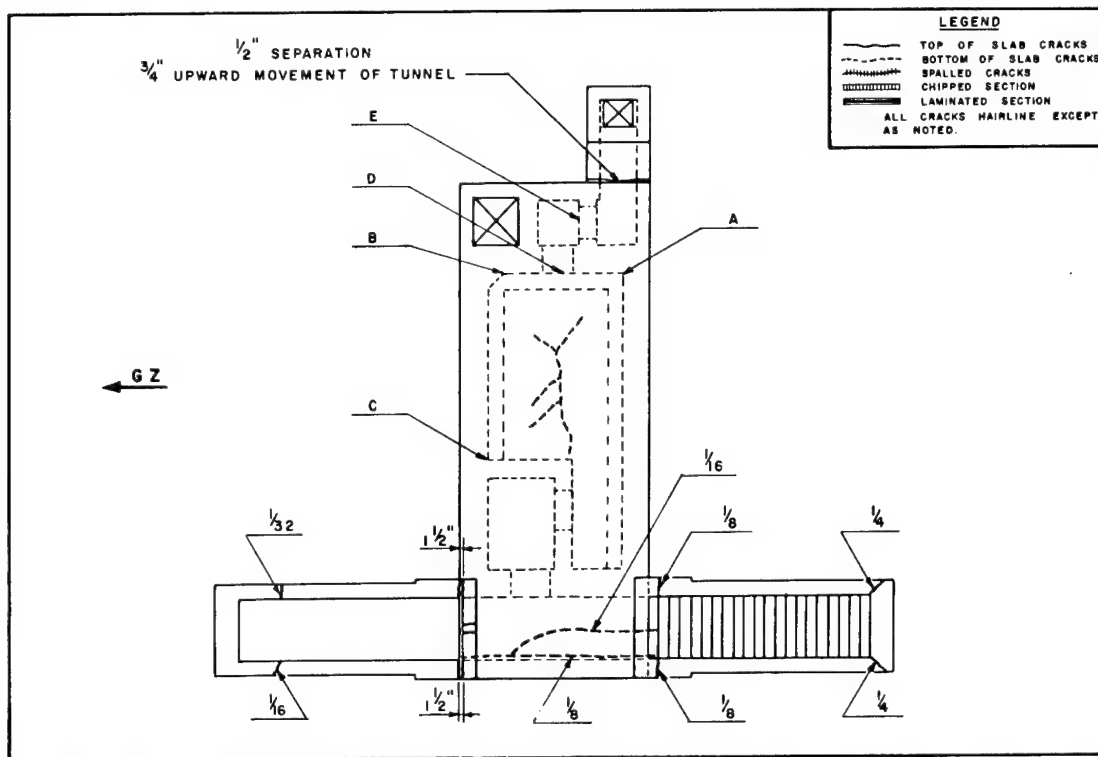
Fig. 3.33—Roof-slab crack pattern (structure RAc).

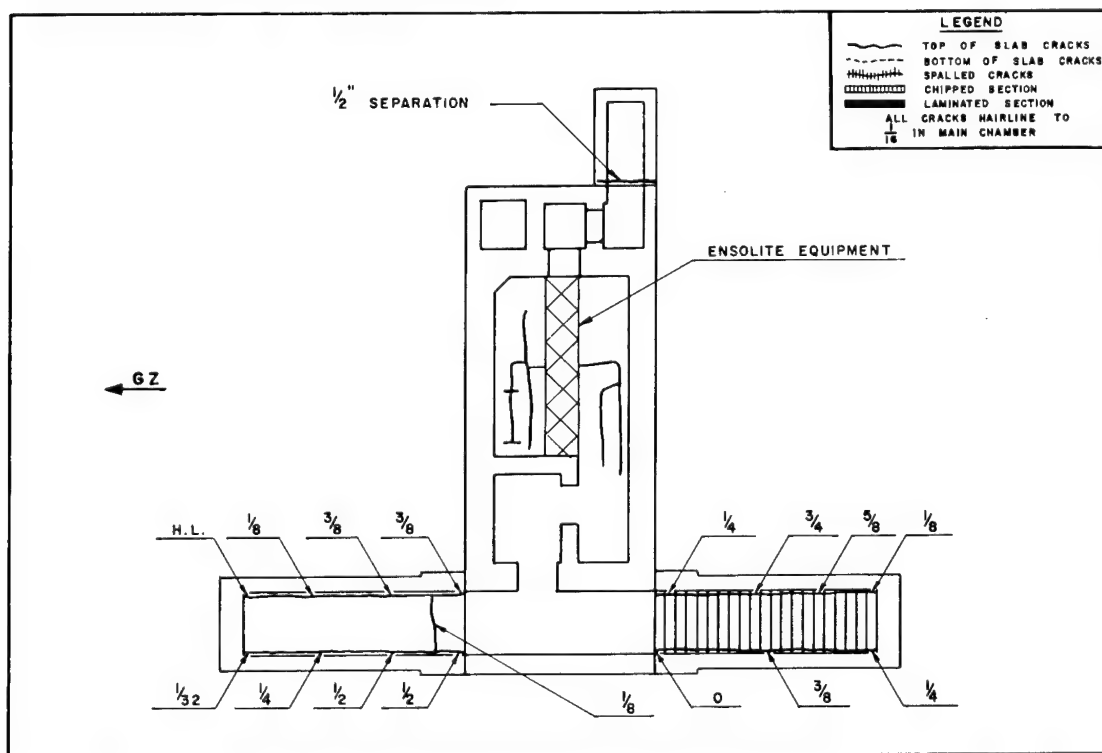
Fig. 3.34—Floor-slab crack pattern (structure RAc).

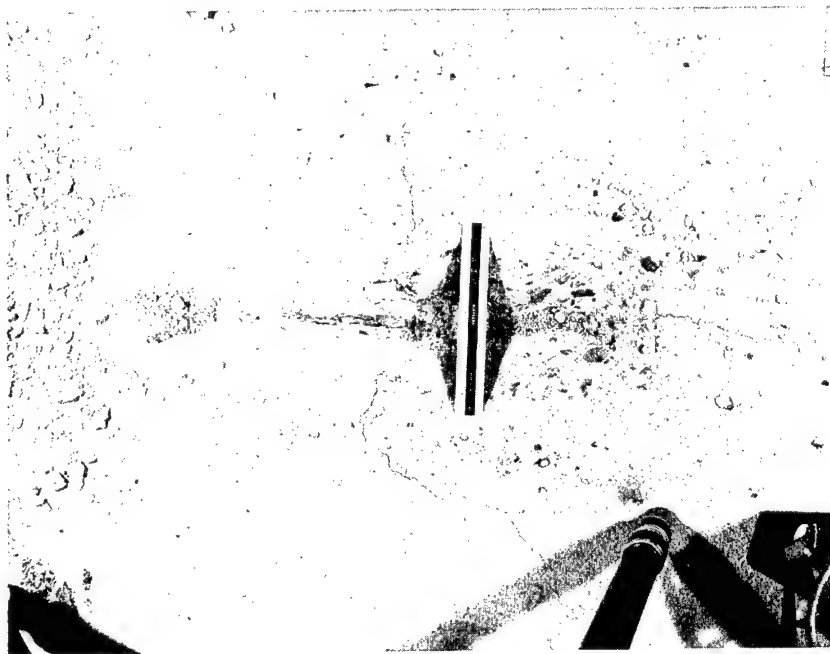
Fig. 3.38—Over-all view of chipped-out section with associated crack pattern (structure RAc).

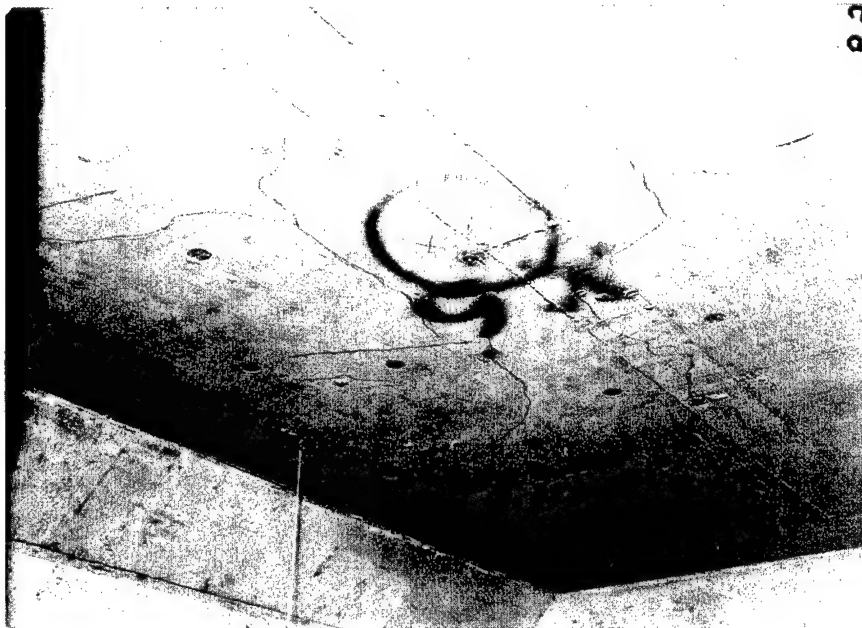
Fig. 3.43—Cracks in roof slab of main chamber (structure RAc).

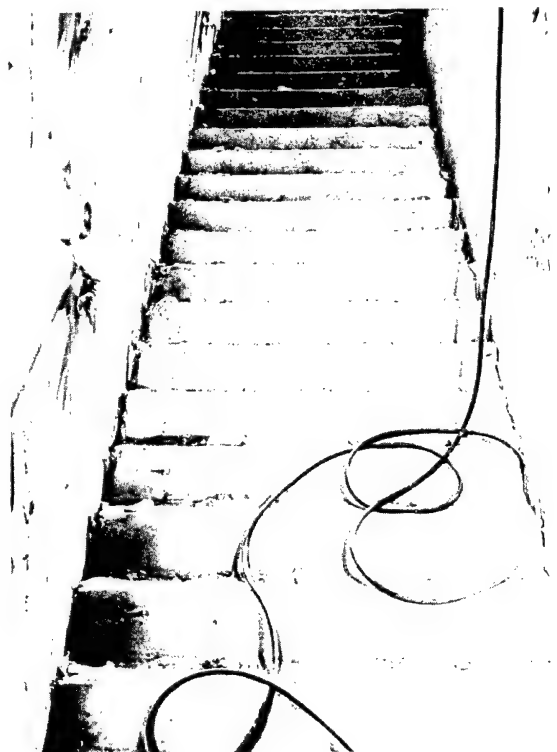
Fig. 3.46—Looking up stairs facing away from GZ, showing separations between stairs and interior and entrance walls (structure RAc).

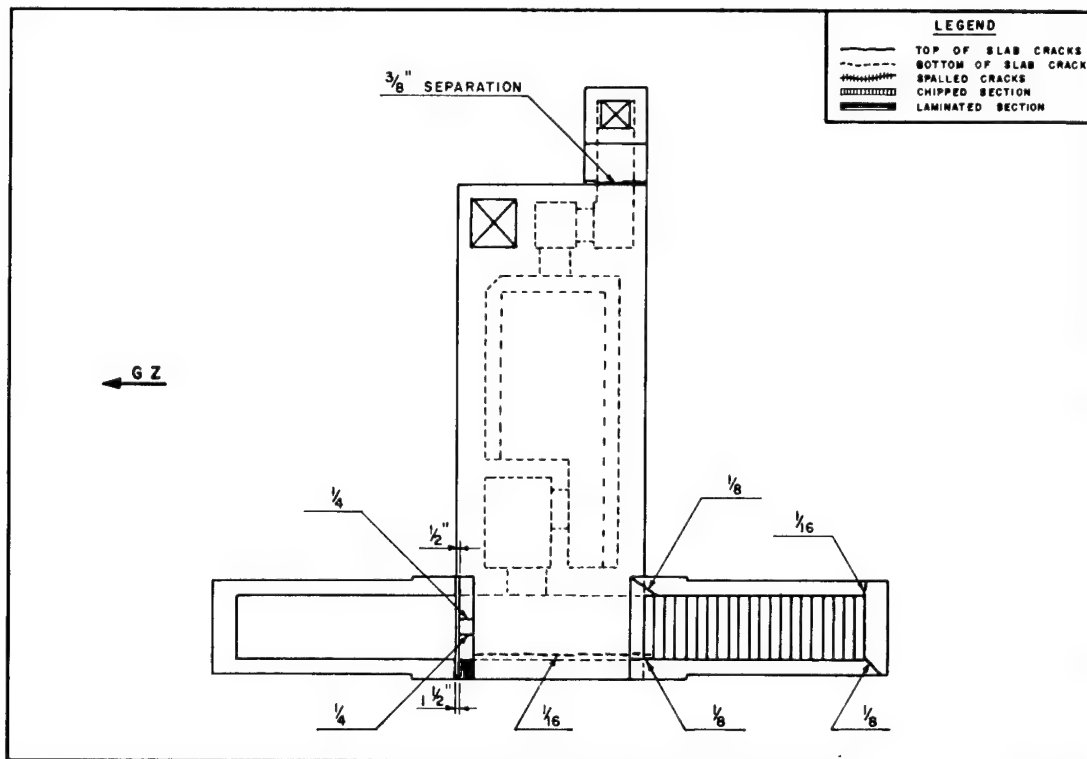
Fig. 3.54—Roof-slab crack pattern (structure RAd).

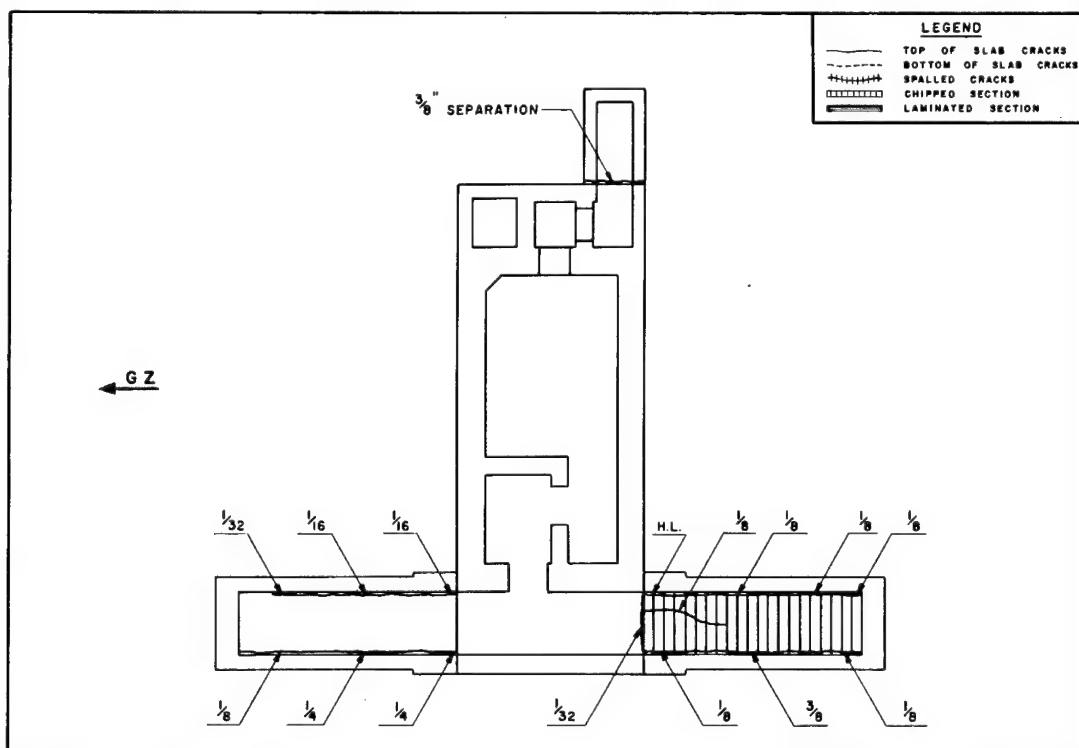
Fig. 3.55—Floor-slab crack pattern (structure RAd).

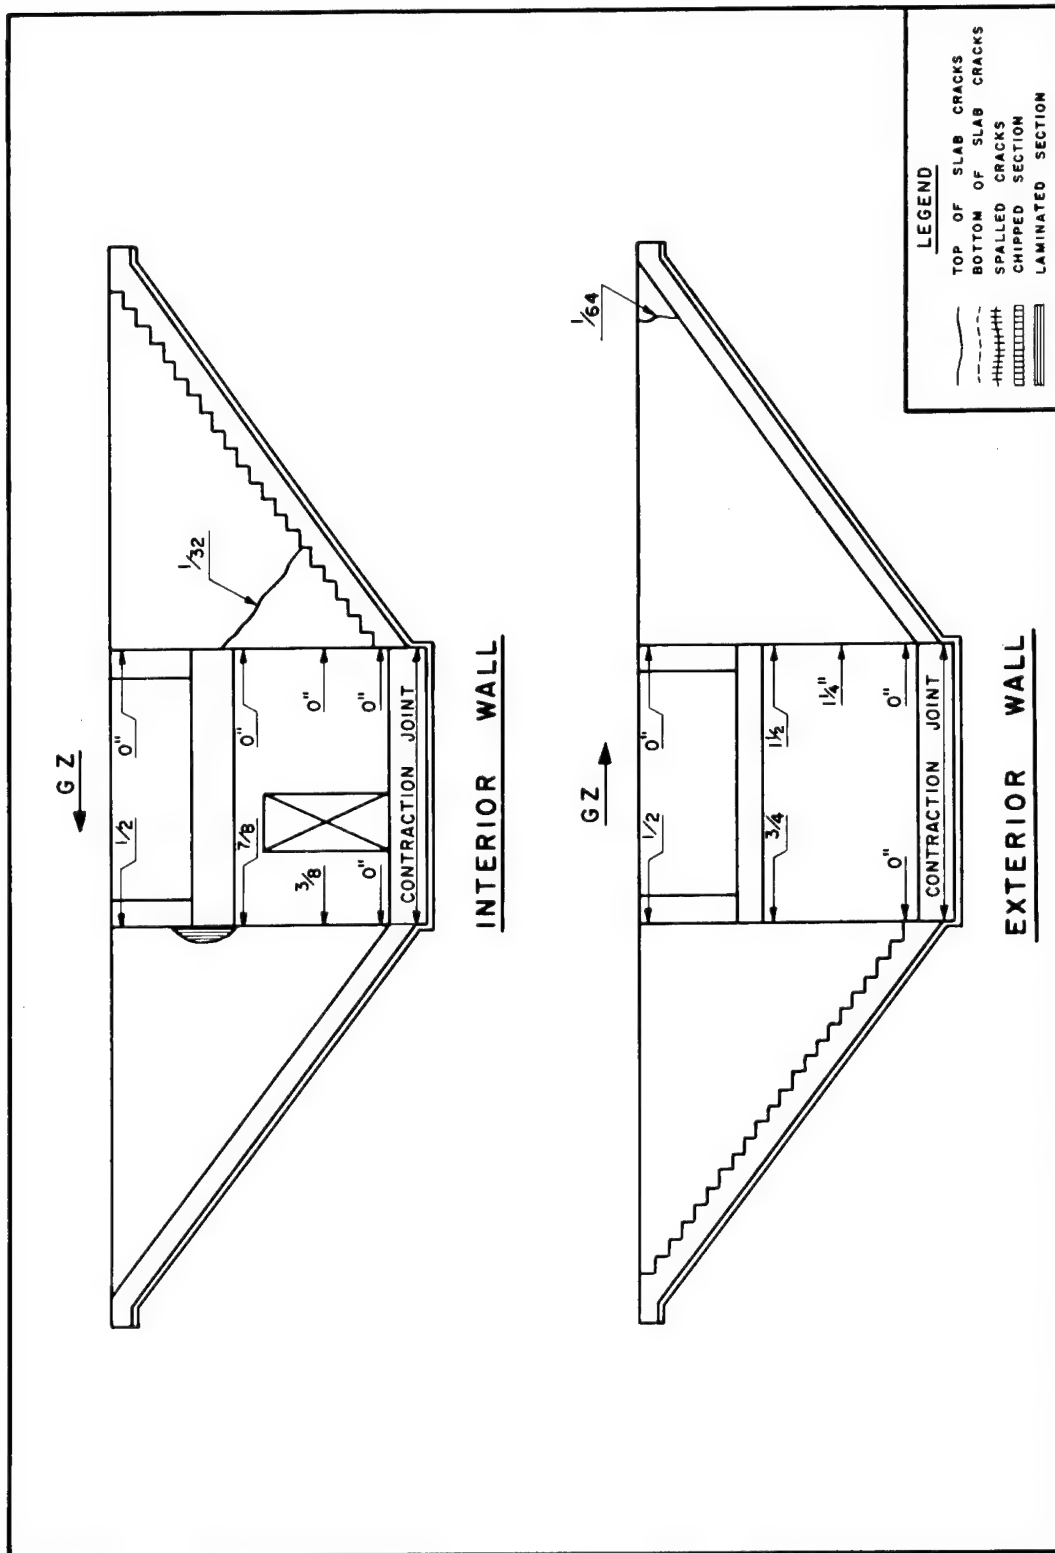
Fig. 3.56—Entrance crack pattern (structure RAD).

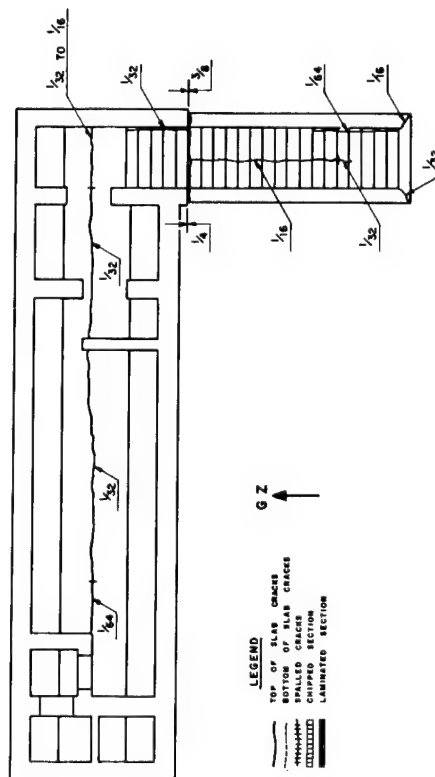
Fig. 3.59—Floor-slab crack pattern (structure CAa).

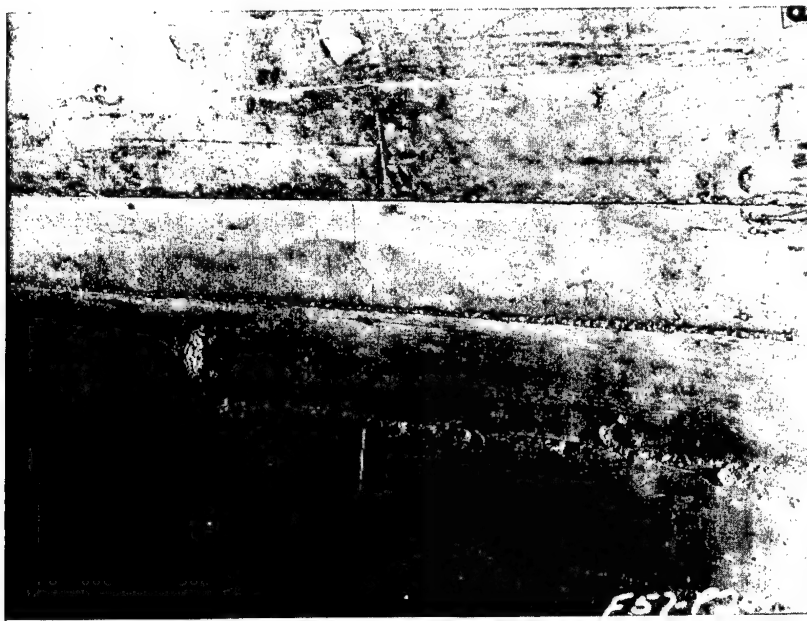
Fig. 3.64—Crack in the main chamber at approximately the center of the side facing toward GZ (structure CAa).

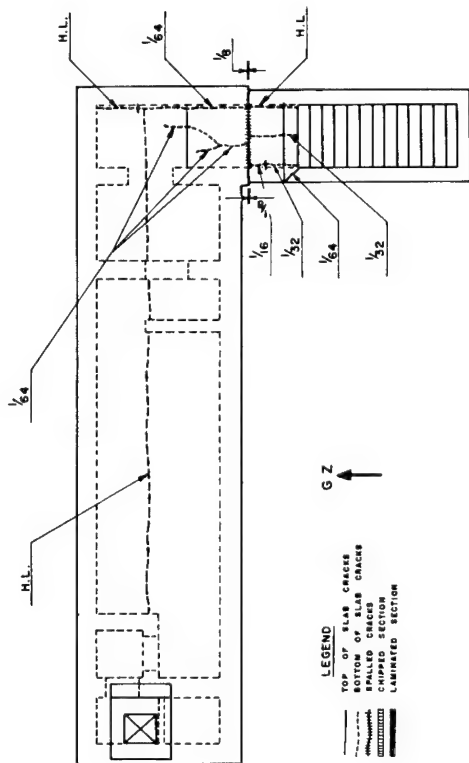
Fig. 3.73—Roof-slab crack pattern (structure CAb).

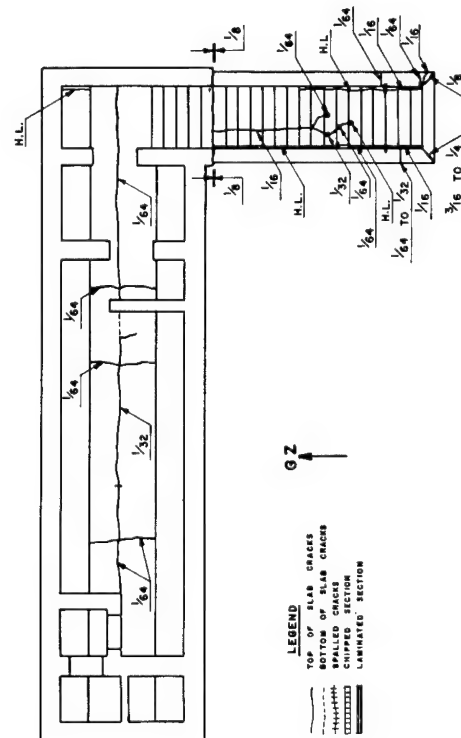
Fig. 3.74—Floor-slab crack pattern (structure CAb).

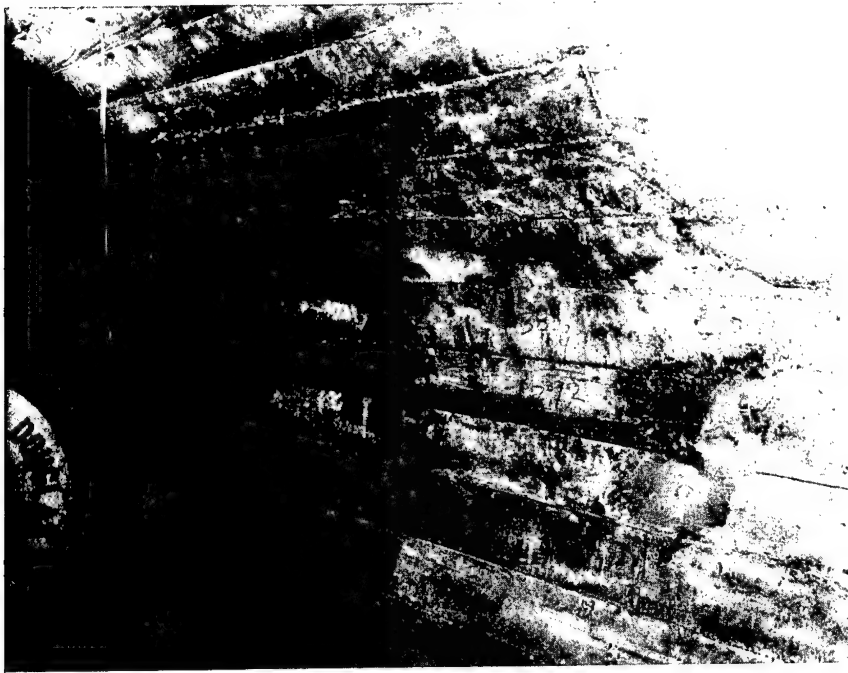
Fig. 3.76—Side of main chamber facing toward GZ (structure CA b). Note cracks by survey point X-4 and horizontal cold joint.

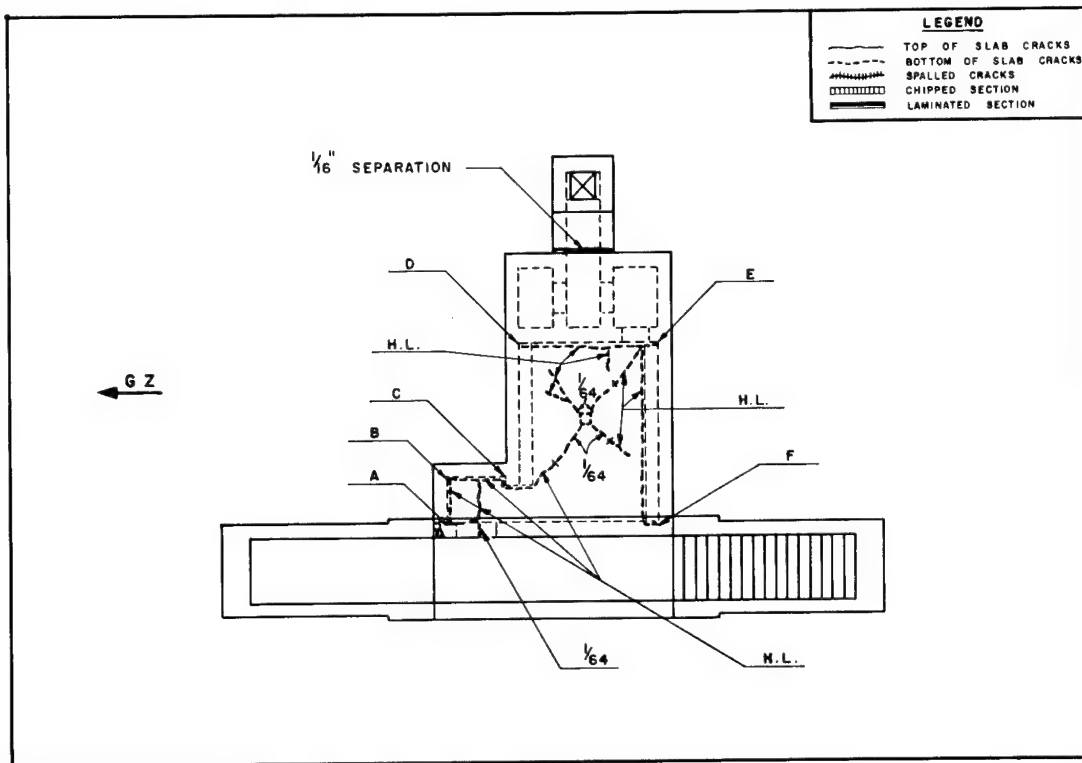
Fig. 3.82—Roof-slab crack pattern (structure RCa).

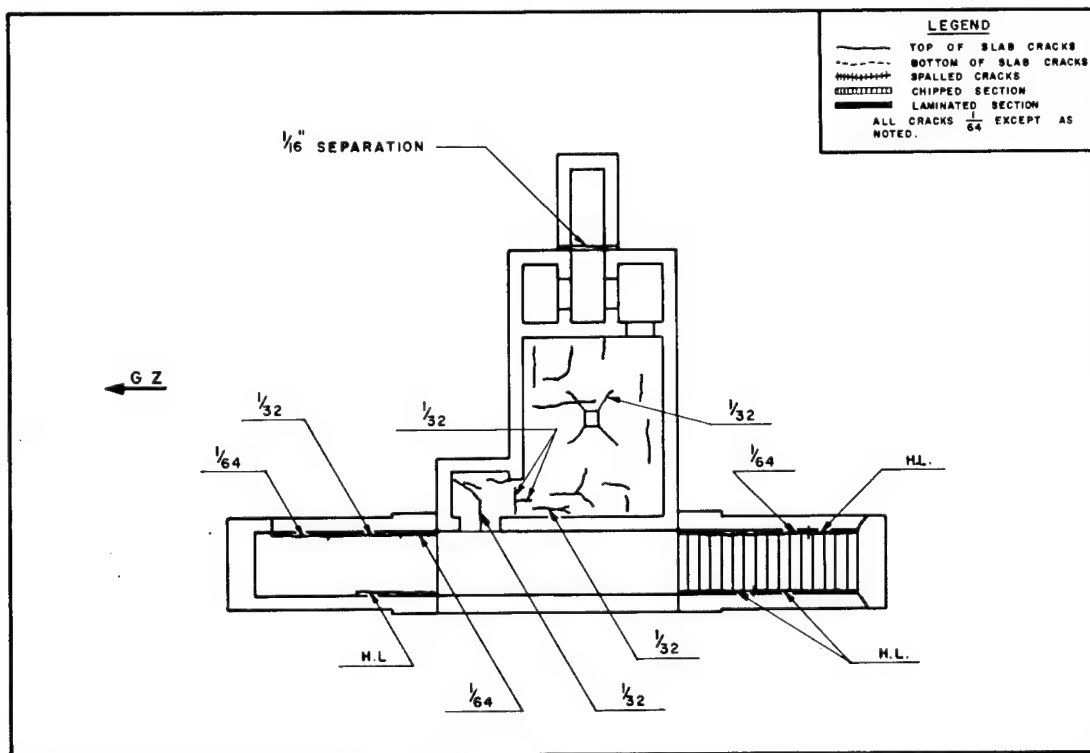
Fig. 3.83—Floor-slab crack pattern (structure RCa).
